SOUTH GATE GIRLS CLUB HOUSE

FEASIBILITY STUDY DRAFT REPORT

LEHRER ARCHITECTS LA FEBRUARY 22, 2017

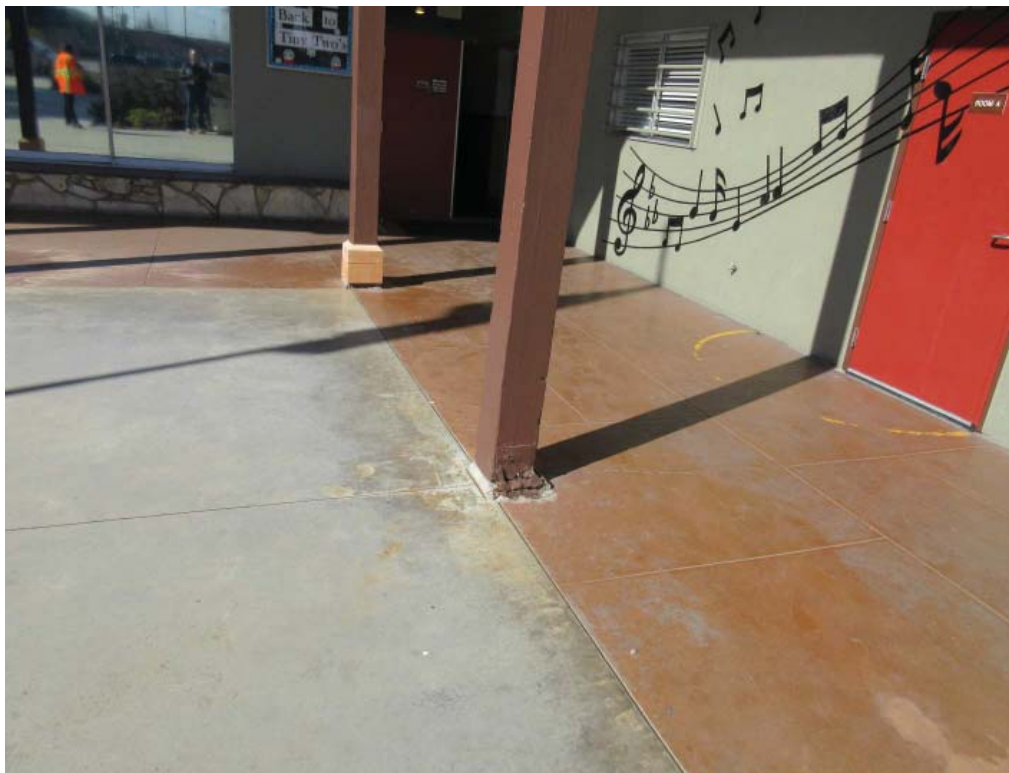
- Deteriorated corroded base hardware connection at one colonnade column at the front entrance. Bottom of the post can be cut and new post base hardware installed to lift it off the ground.
- Cracks in concrete slab on grade such as the front entrance.

Photo 6 – Entrance wood framed colonnade column with deteriorated corroded base connection.

1. One colonnade column at the front entrance exhibited deteriorated base hardware, could be solved by cutting the bottom of the post and install new post base hardware
2. Cracks in the existing slab on grade such as at the front entrance

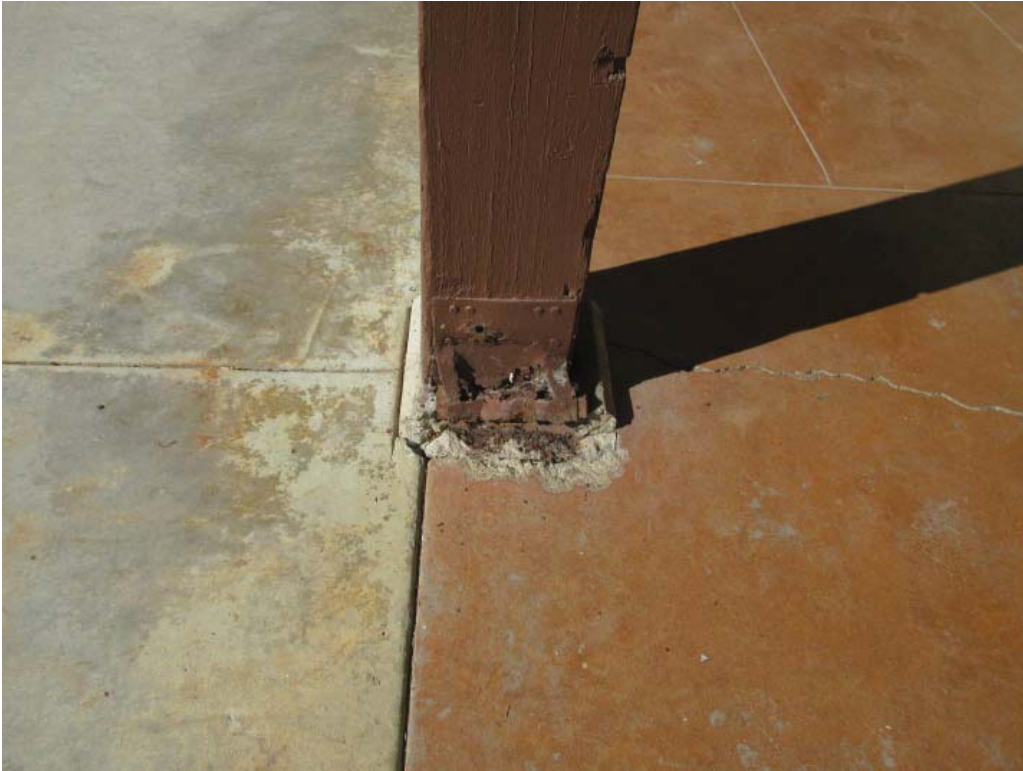
Photo 7 – Close up of Photo 6.

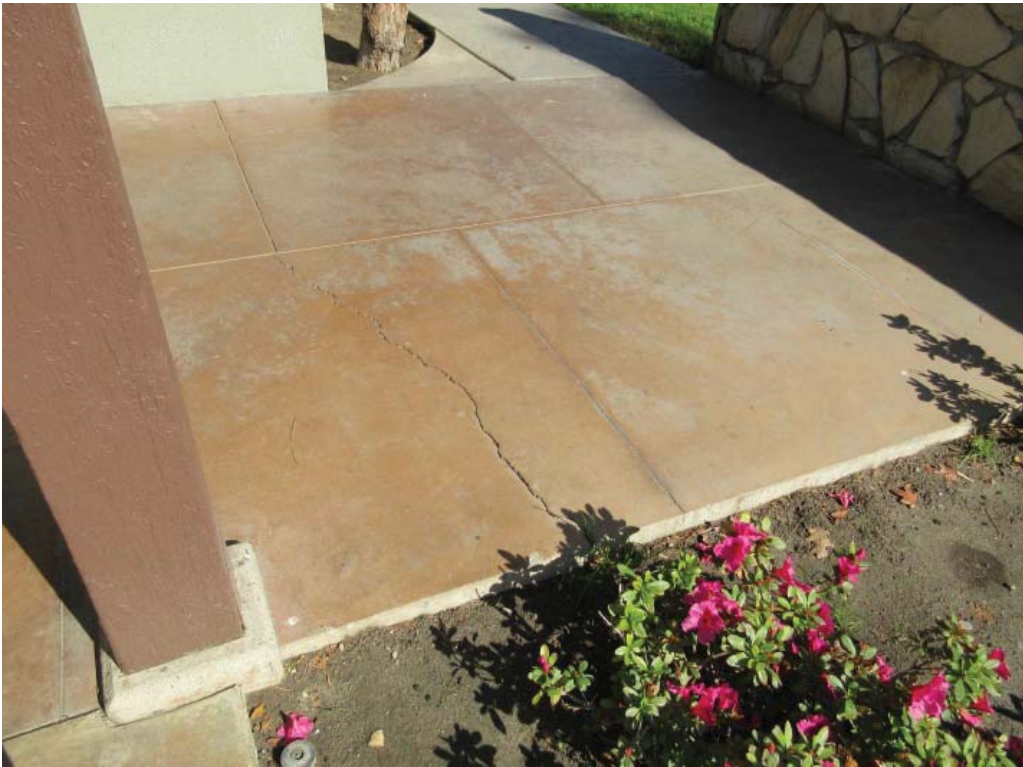
Photo 8 – Crack in slab on grade at front entrance.

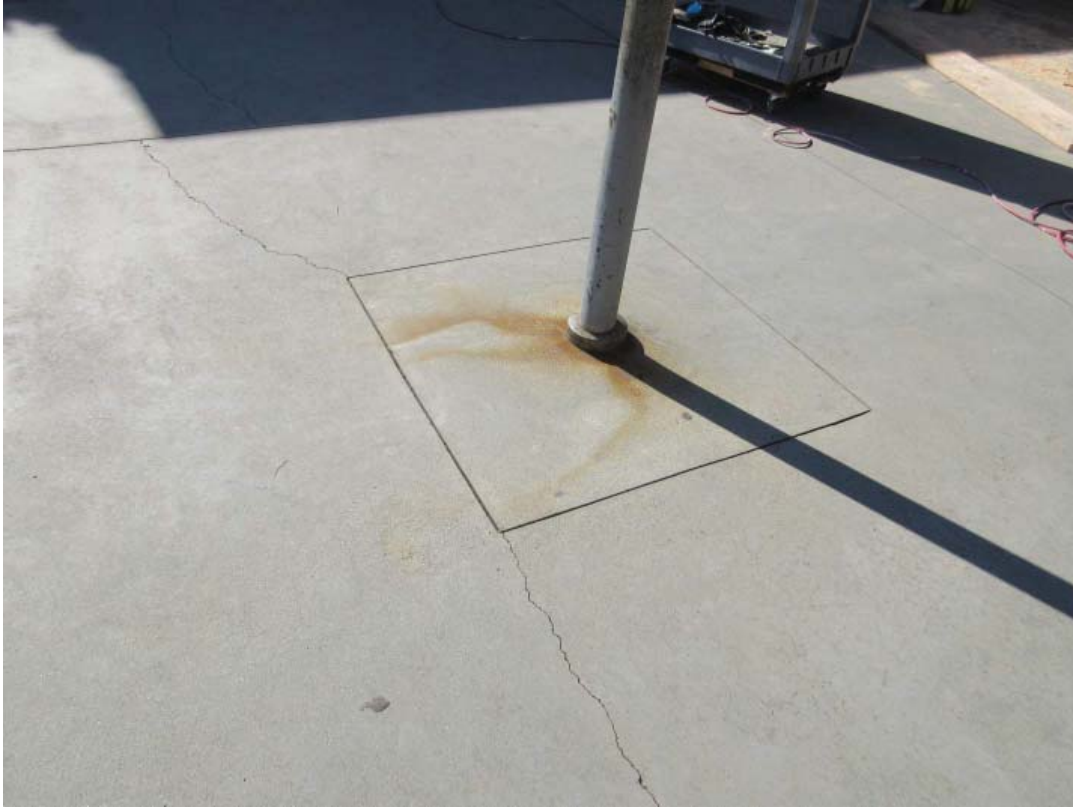
Photo 9 – Cracks in slab on grade near flag pole at front entrance,

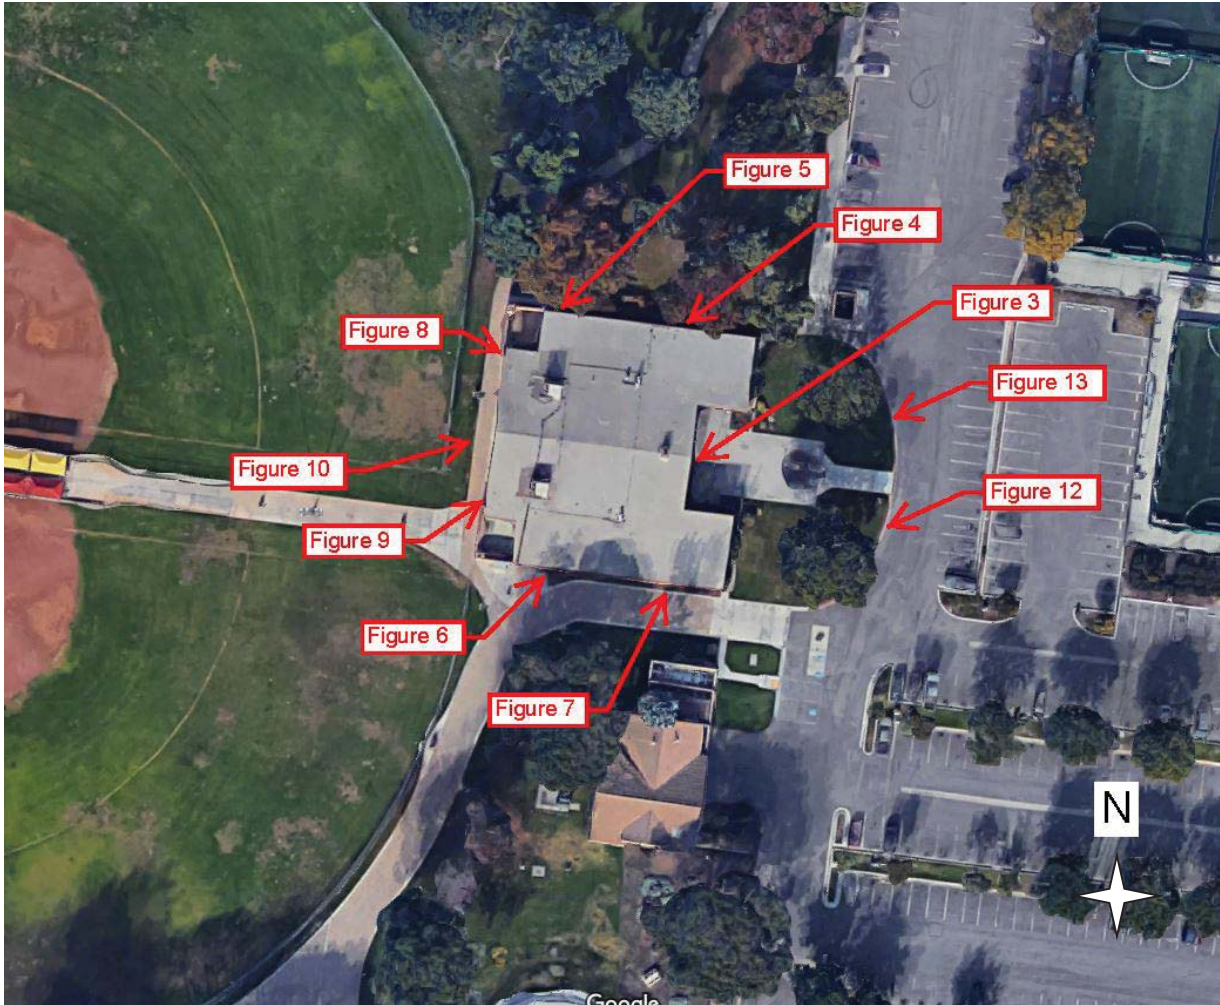
Figure 2: Plan location reference where figures were taken on the next 6 pages

Overall, since there is no existing stormwater drainage system on-site then it is highly recommended that the stormwater be redirected towards the curb and gutter located along the parking lot as shown on figure 11, 12, and re 13. The stormwater from the downspouts and hardscape will curb drain to the existing curb and gutter flowing the water off site and into the cities storm drainage system. Regrading in the landscape area might be required in order to create stormwater flow to end up in the curb and gutter towards the east.

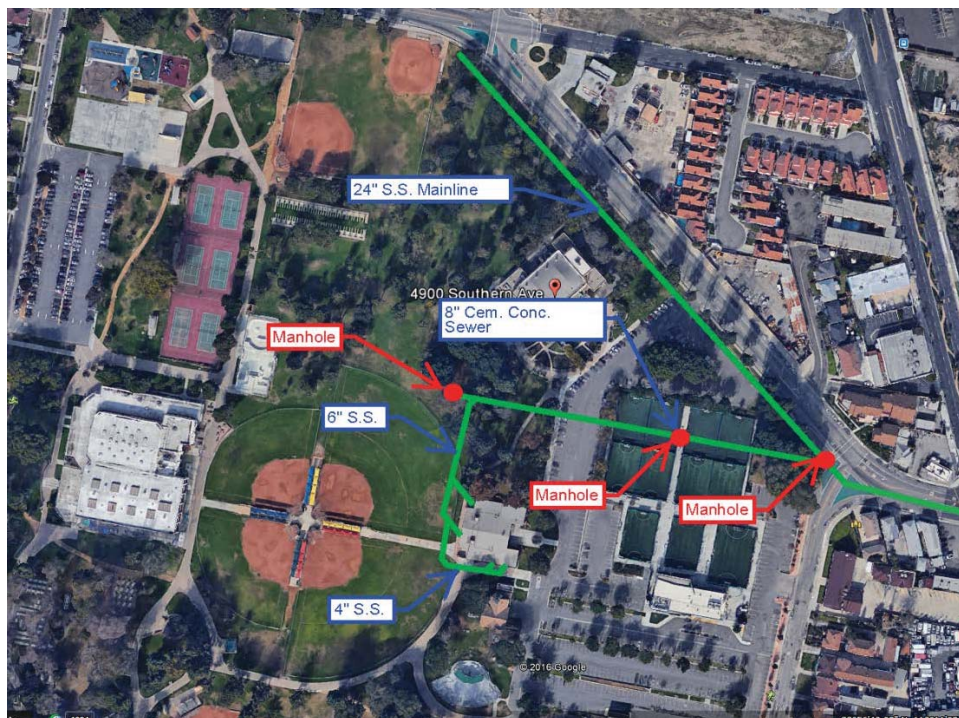
The existing Clubhouse building on site discharges through a 4” dia lateral sewer pipe on the south end and flows into a 6” dia sewer pipe on the back end of the property. The pipe connects through 8” dia. concrete pipe all the way to the 24” dia. LA County sewer main line located along Southern Ave., as shown in figure 14, per sheet 2 of Electrical Utility Plan from Southern California Edison (year unknown). It is recommended that a underground utility survey be done on site to verify with the as-built drawings and our findings.

Figure 14: Existing sewer utility line

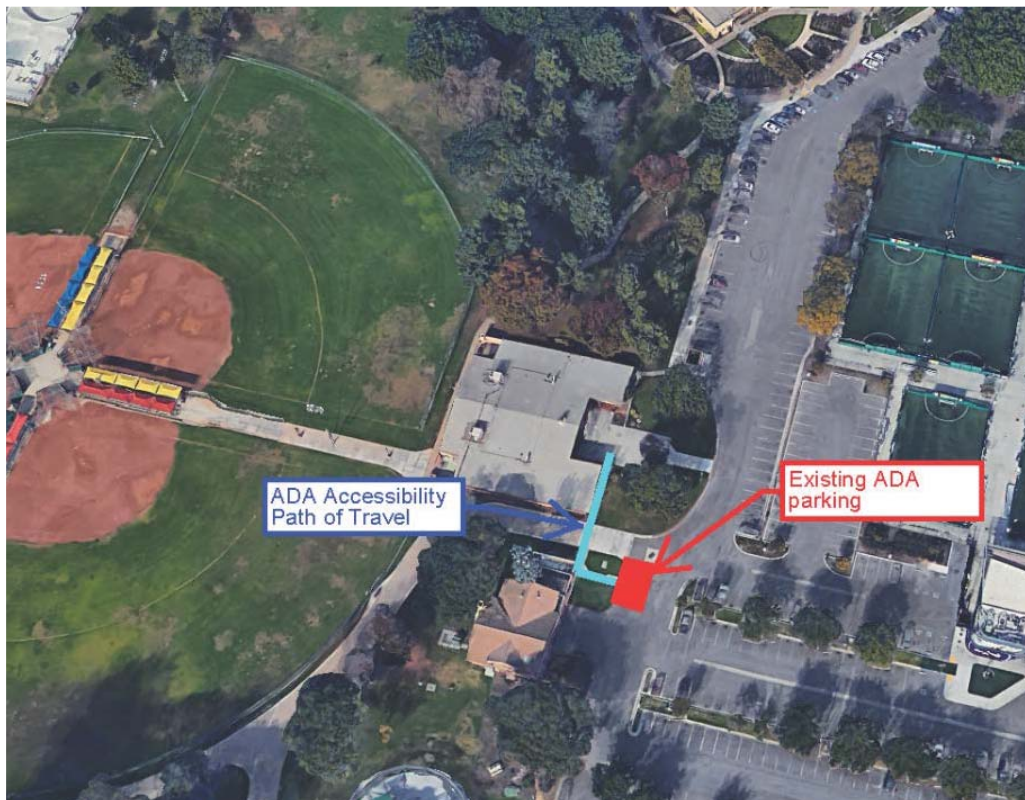
Figure 16 and 17 below show the current existing ADA path of travel to the Girls Club House. There currently are 3 existing ADA parking stalls next to an accessible path which leads to the main entrance of the existing building. An issue we currently found on-site is that the 2 access doors in the back of the building will are not ADA compliant as shown on figure 18. The access to these doors will need to be ADA compliant by adding a ramp. Per the County of LA ADA requirements, if any ADA access is between a 2-5% slope then it is considered a ramp and if the slope is between 5-8.33% then the ramp will require handrails. No ADA ramp may exceed a slope of 8.33%.

Figure 16: Location of ADA accessible ramp to the Girls Club House.
