SOUTH GATE GIRLS CLUB HOUSE

FEASIBILITY STUDY DRAFT REPORT

LEHRER ARCHITECTS LA FEBRUARY 22, 2017

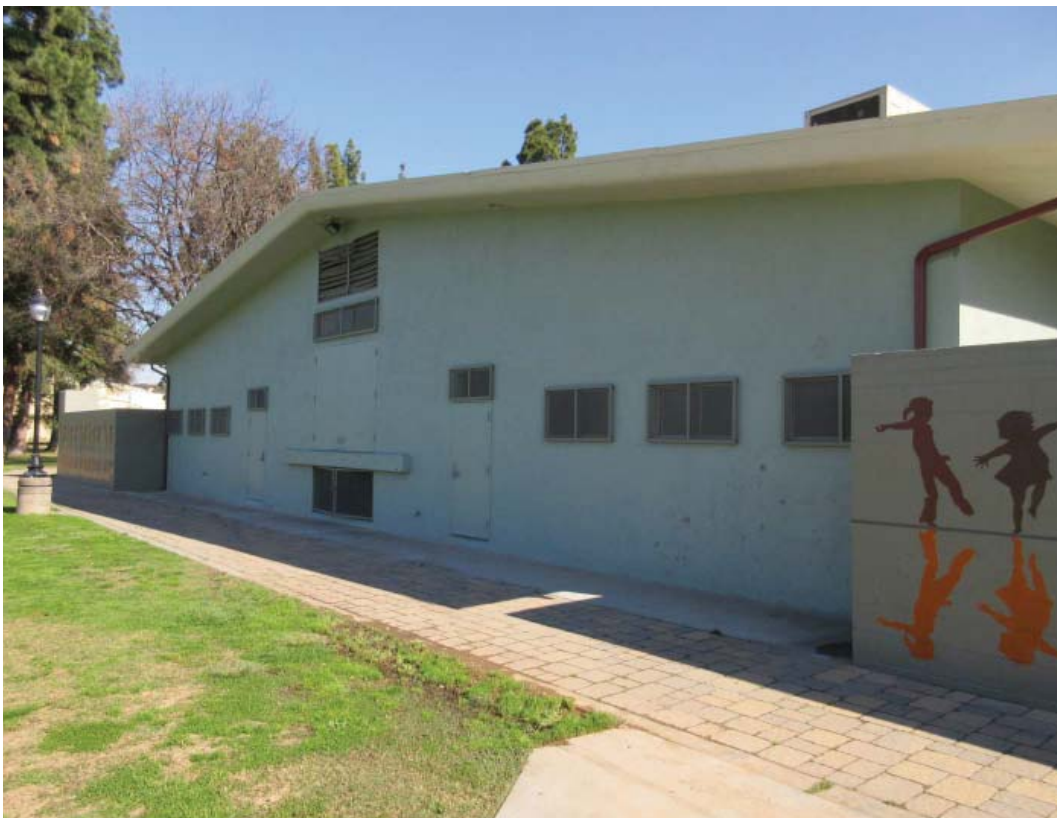
Photo 2 – Rear west elevation.

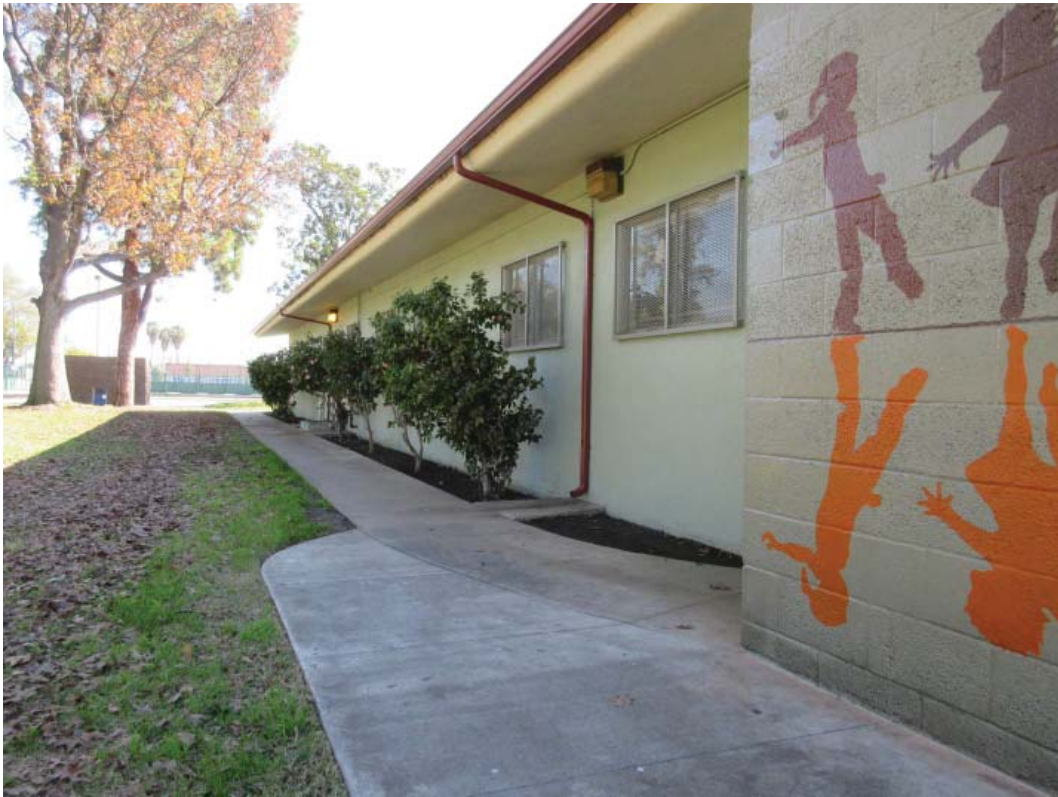
Photo 3 – Side north elevation.

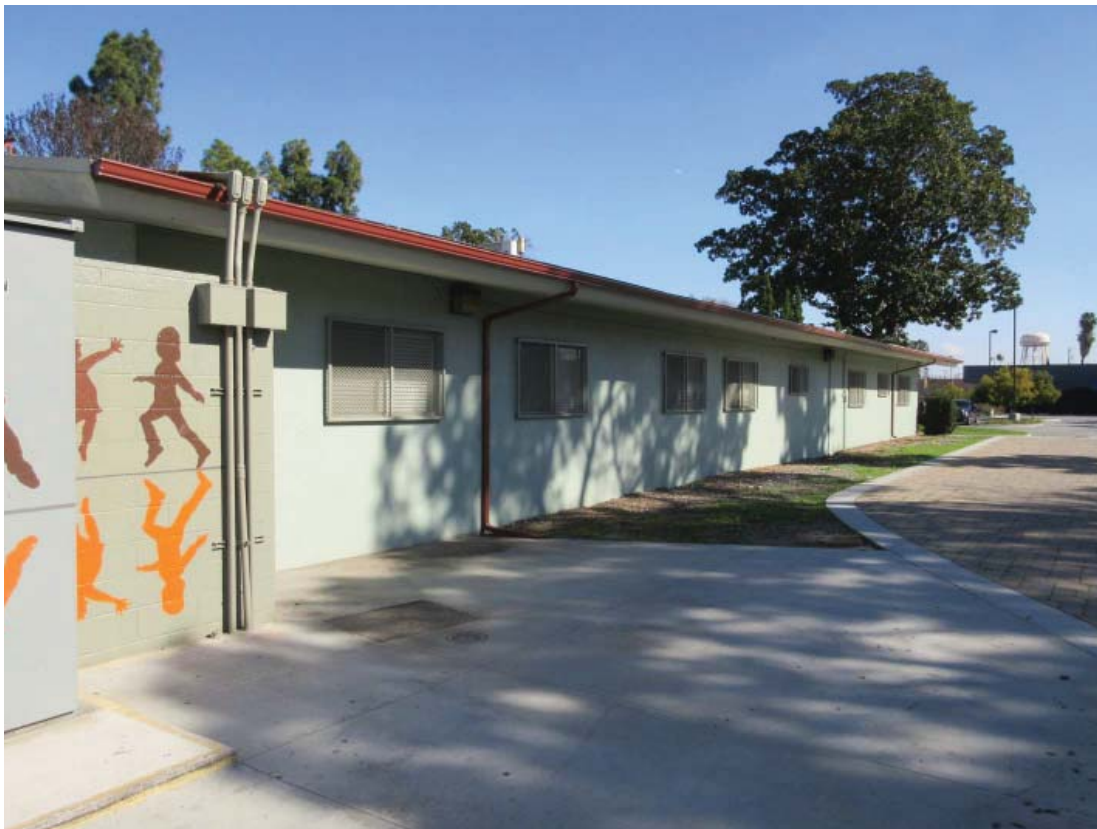
Photo 4 – Side south elevation.

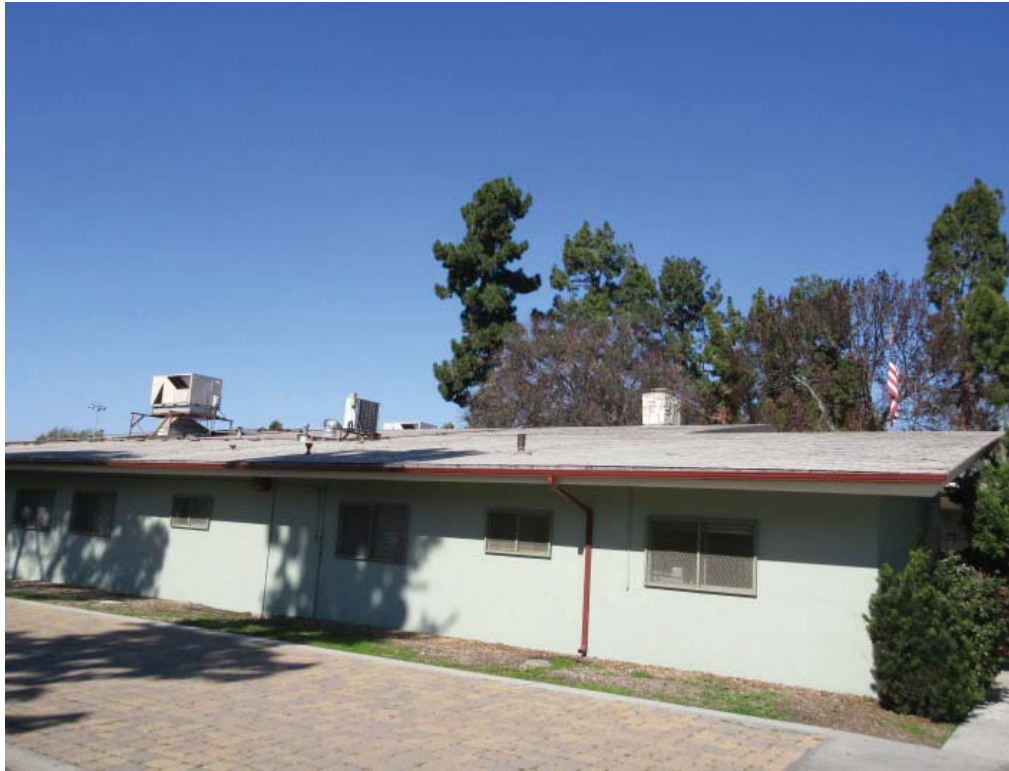
Photo 5 – Roof south elevation.

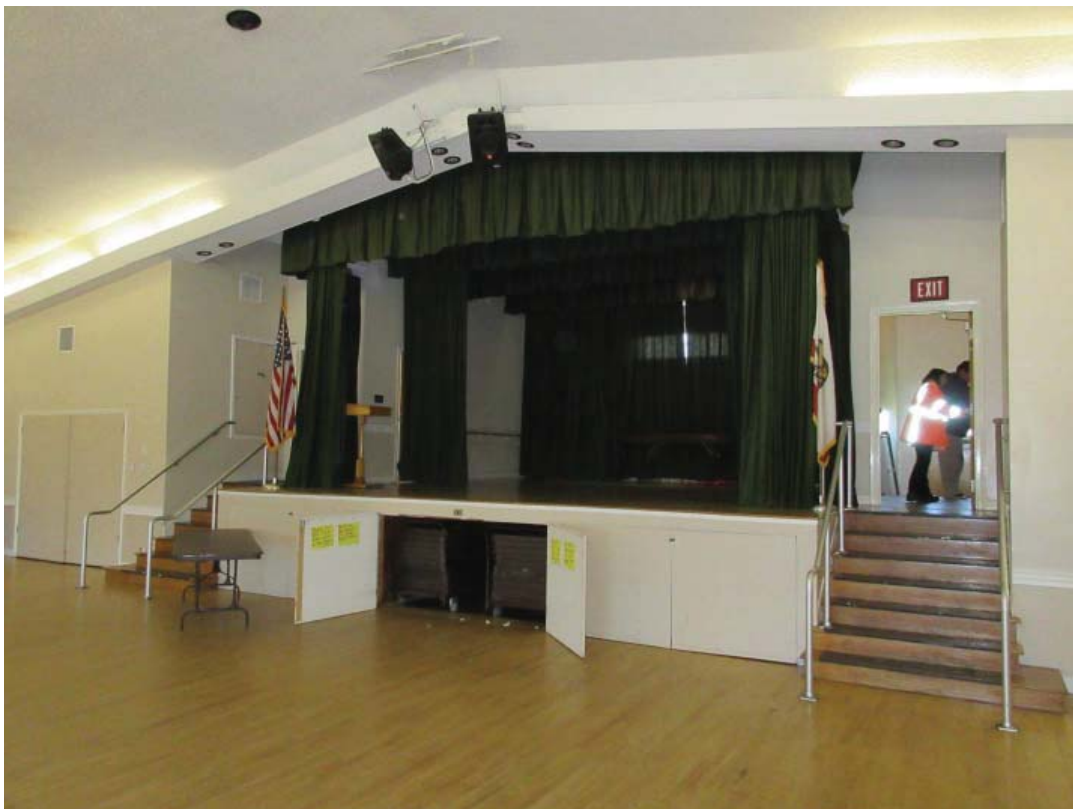
Photo 10 – Front stage platform in assembly room.

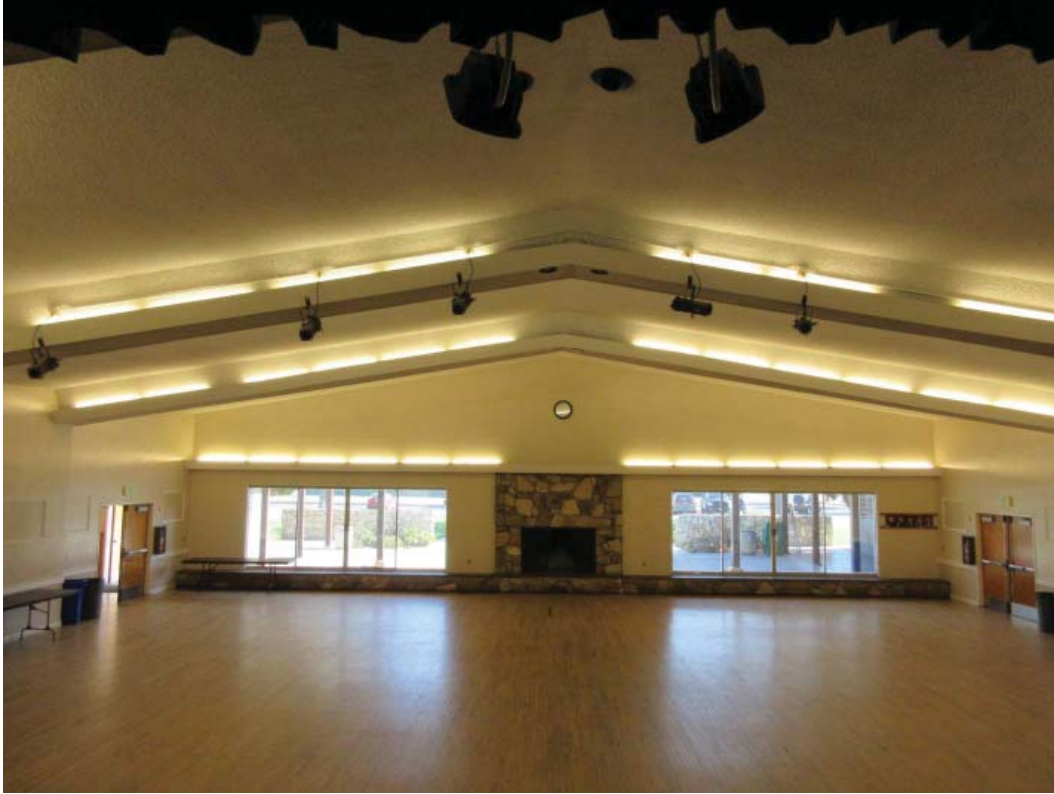
Photo 11 – Assembly room with steel bent frames above the ceiling.

- As a minimum, strengthen the existing stucco and let in braced wood shear walls by adding plywood at strategic locations with hold downs at the wall ends, bolted connections to the foundations, and hardware connections to the horizontal floor and roof diaphragms.
- Consider strengthening the roof and floor diaphragms by adding plywood over the existing sheathing. Further detailed analysis would be required.
- Consider strengthening the beams, columns, foundations, and associated connections at the four interior steel bent frames that support the roof over the assembly room and stage areas. Further detailed analysis would be required.

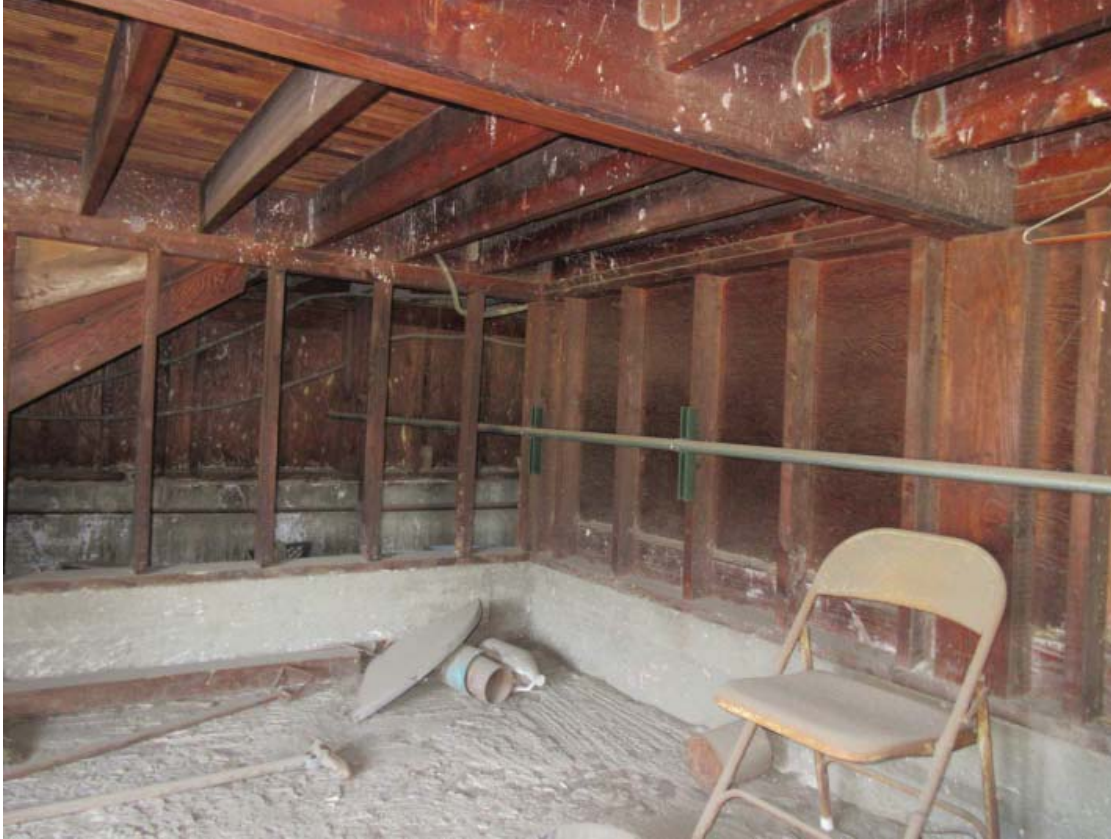
Photo 13 – North and east walls and wood framing below rear stage platform.

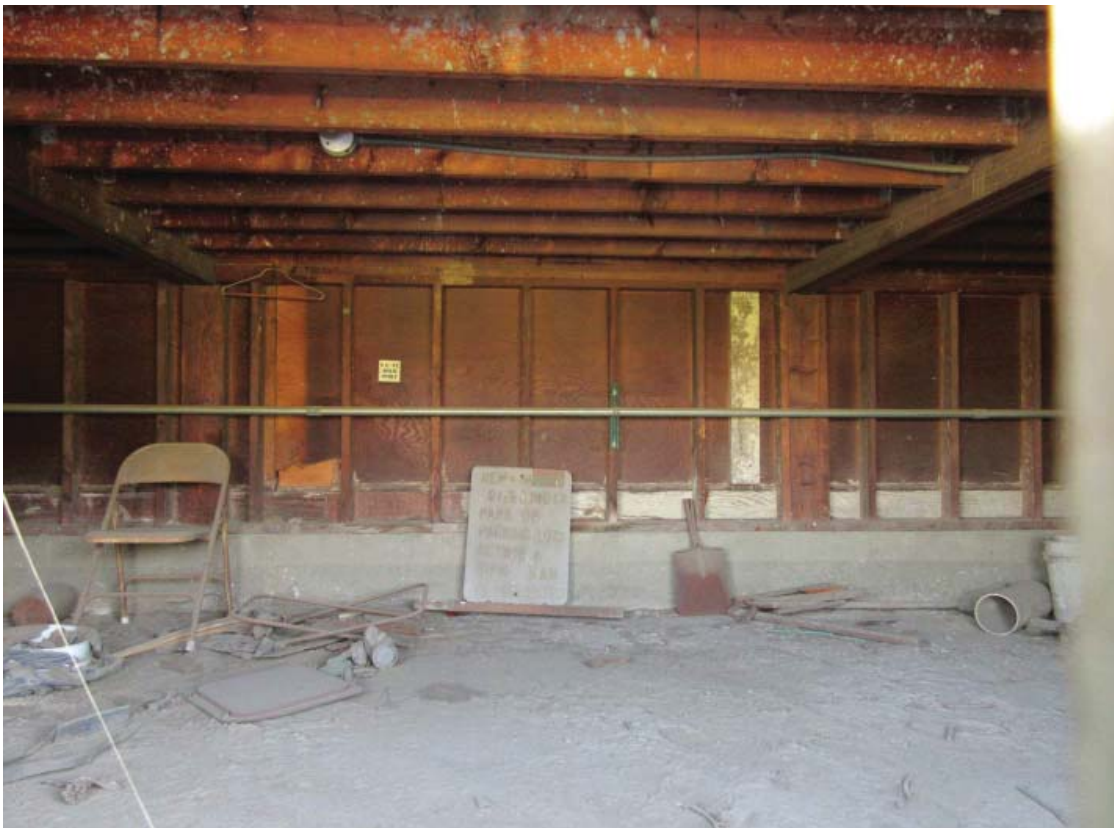
Photo 14 – East wall and wood framing below rear stage platform.

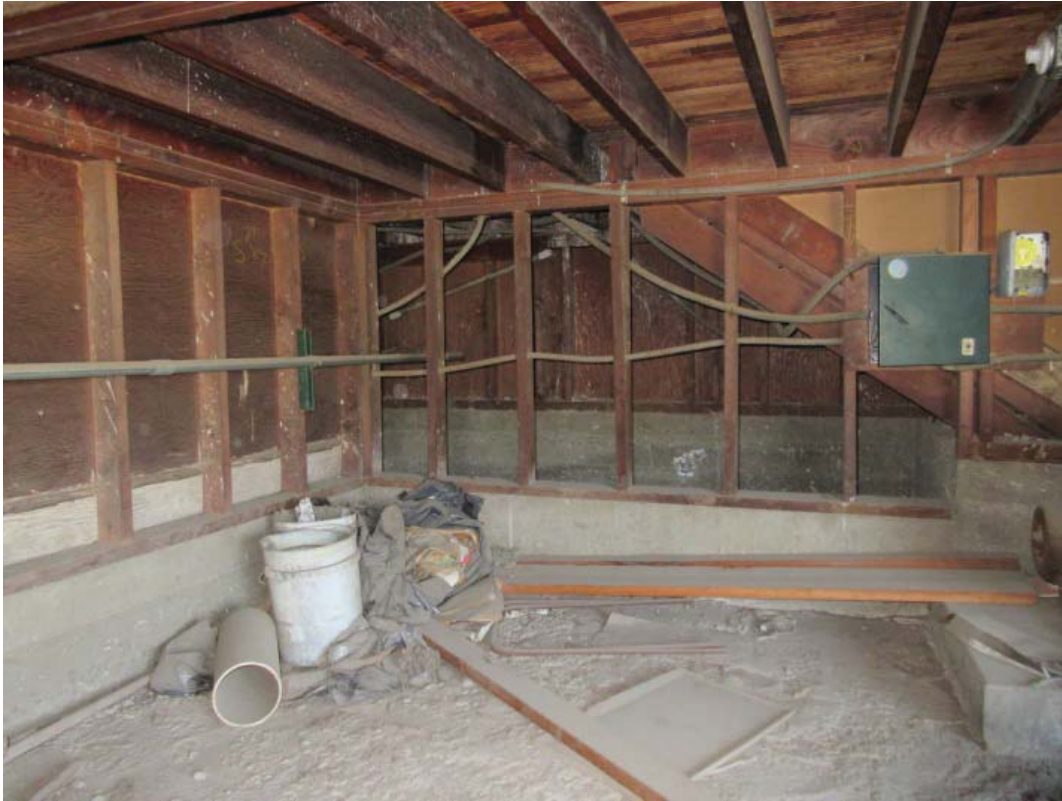
Photo 15 – South and east walls and wood framing below rear stage platform.

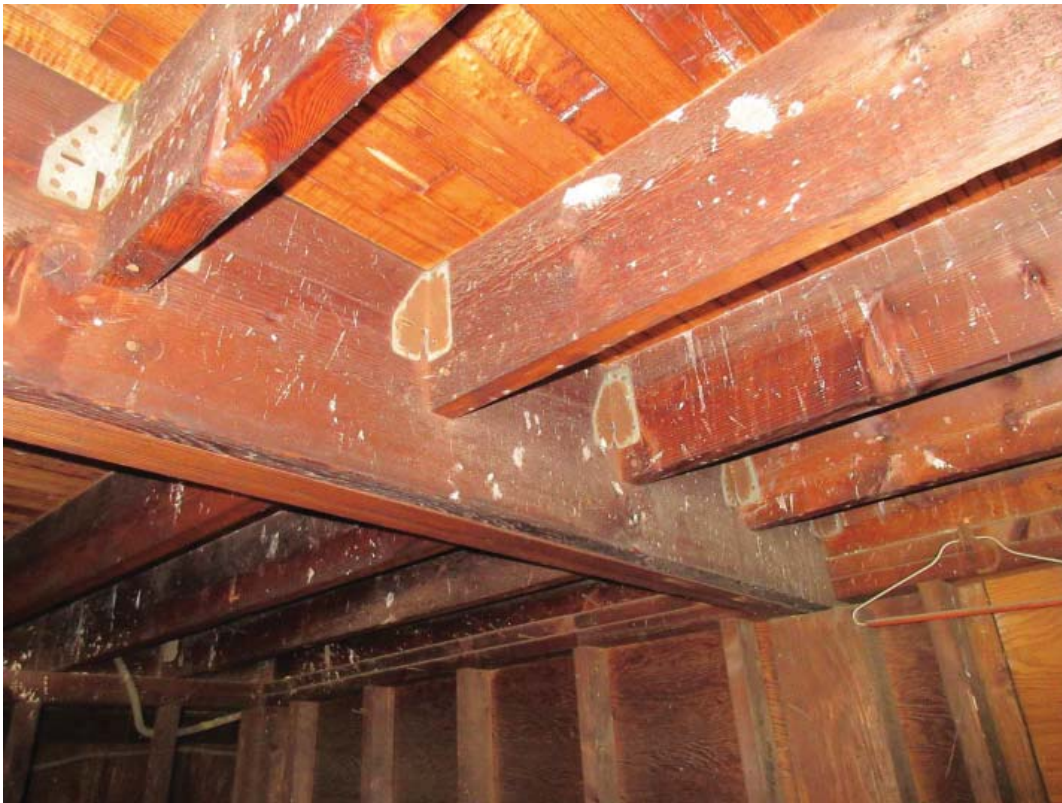
Photo 16 – Close up of wood framing below rear stage platform.

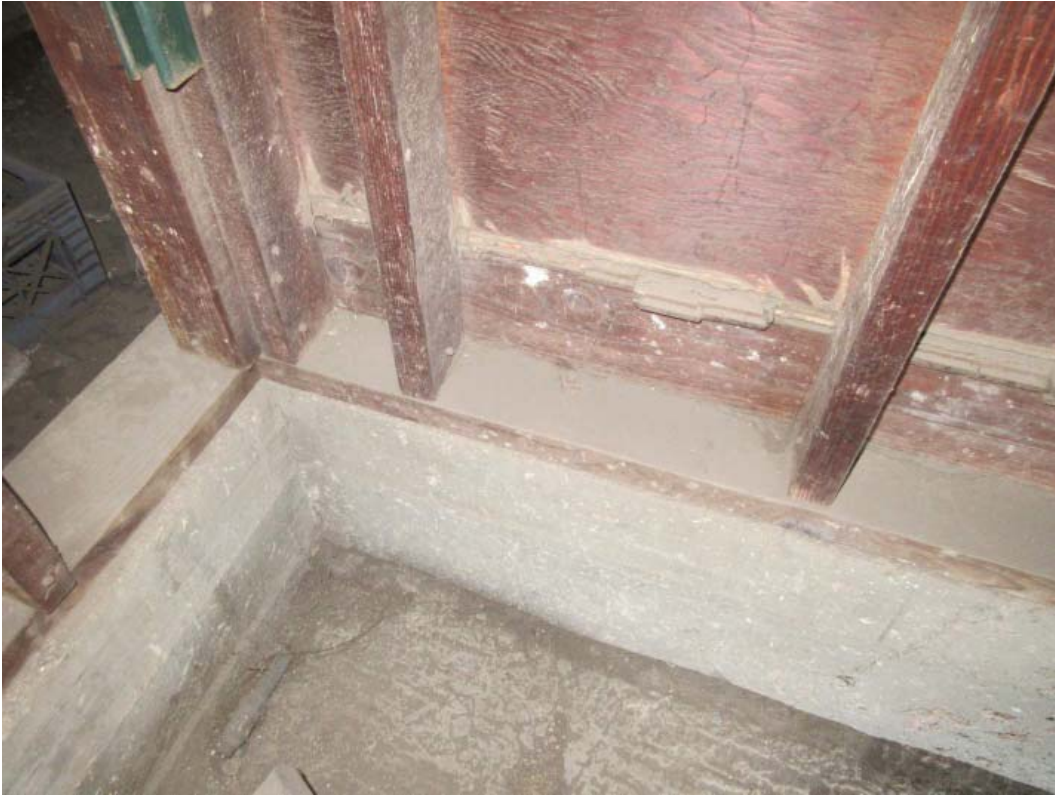
Photo 17 – Close up of north and east wall sill plates with anchor bolts, plywood, and stud framing below rear stage platform.

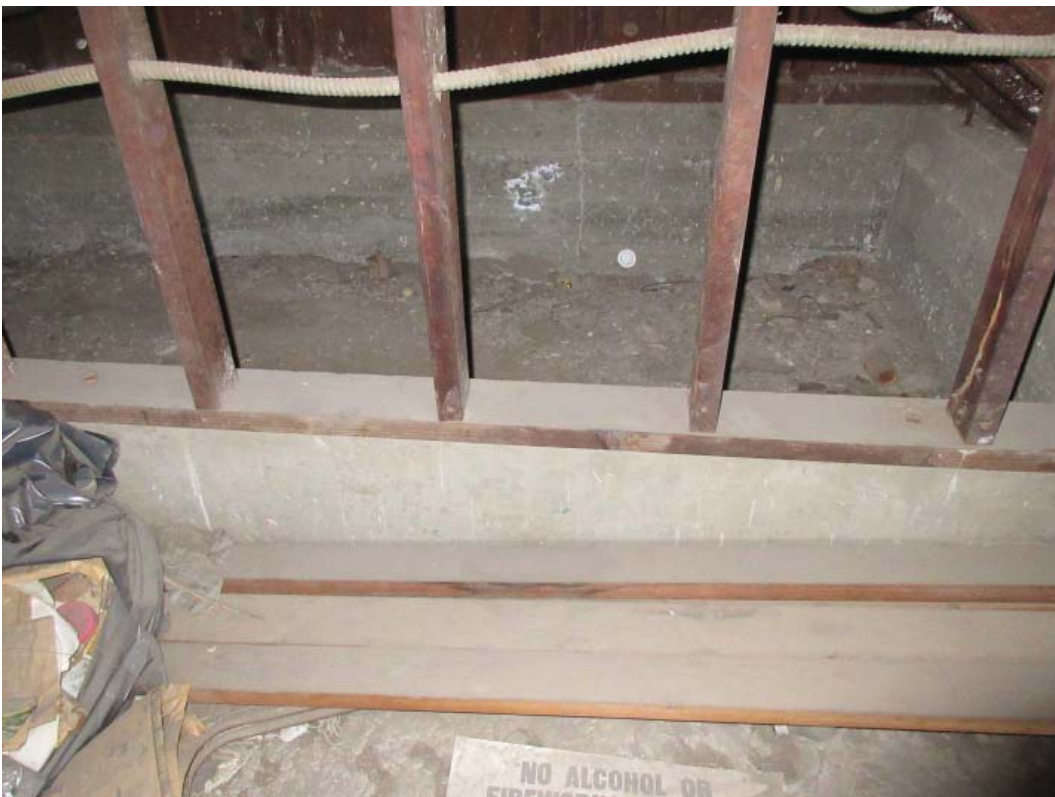
Photo 18 – Close up of north wall sill plates with anchor bolts, plywood, and stud framing below rear stage platform.

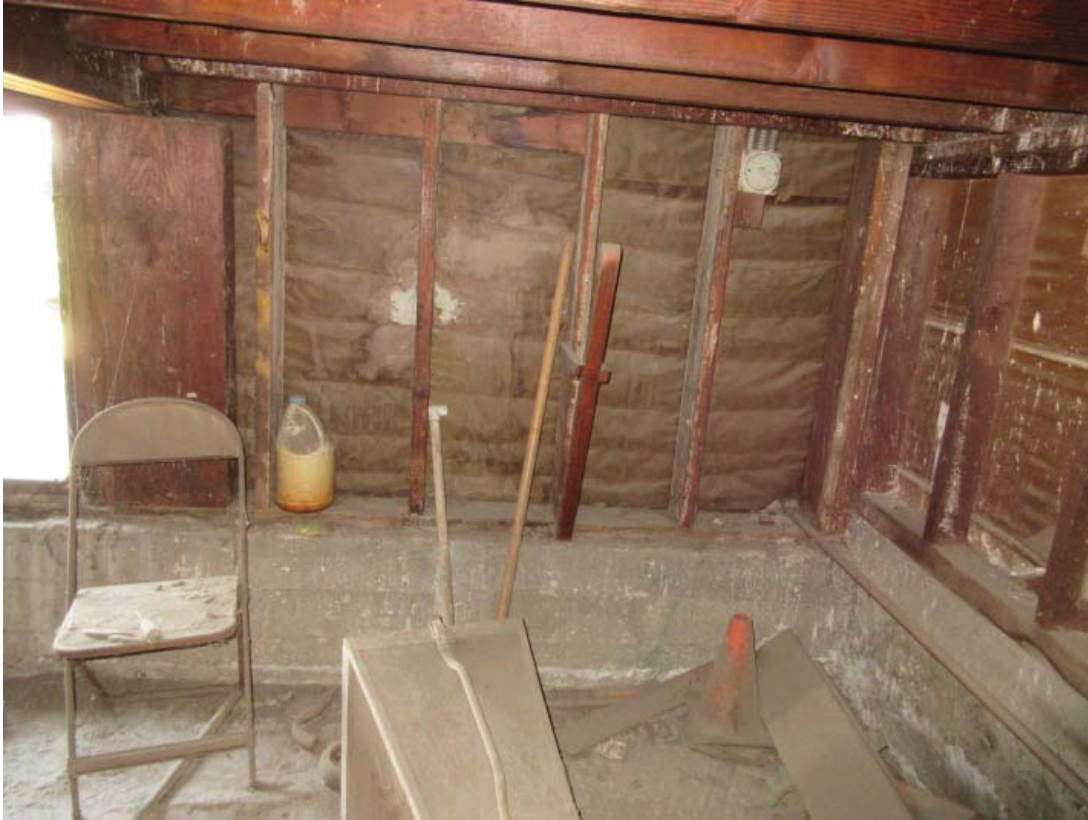
Photo 19 – West wall and wood framing below rear stage platform.

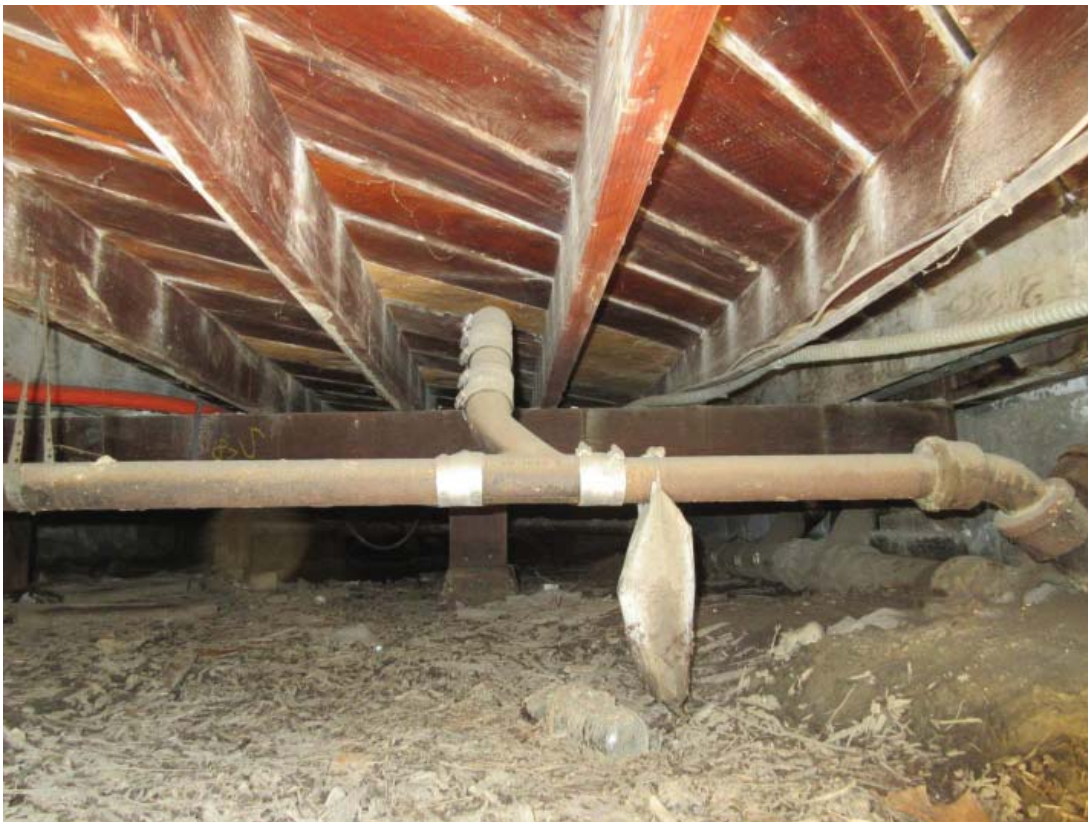
Photo 20 – Framing at south side crawl space below restroom.

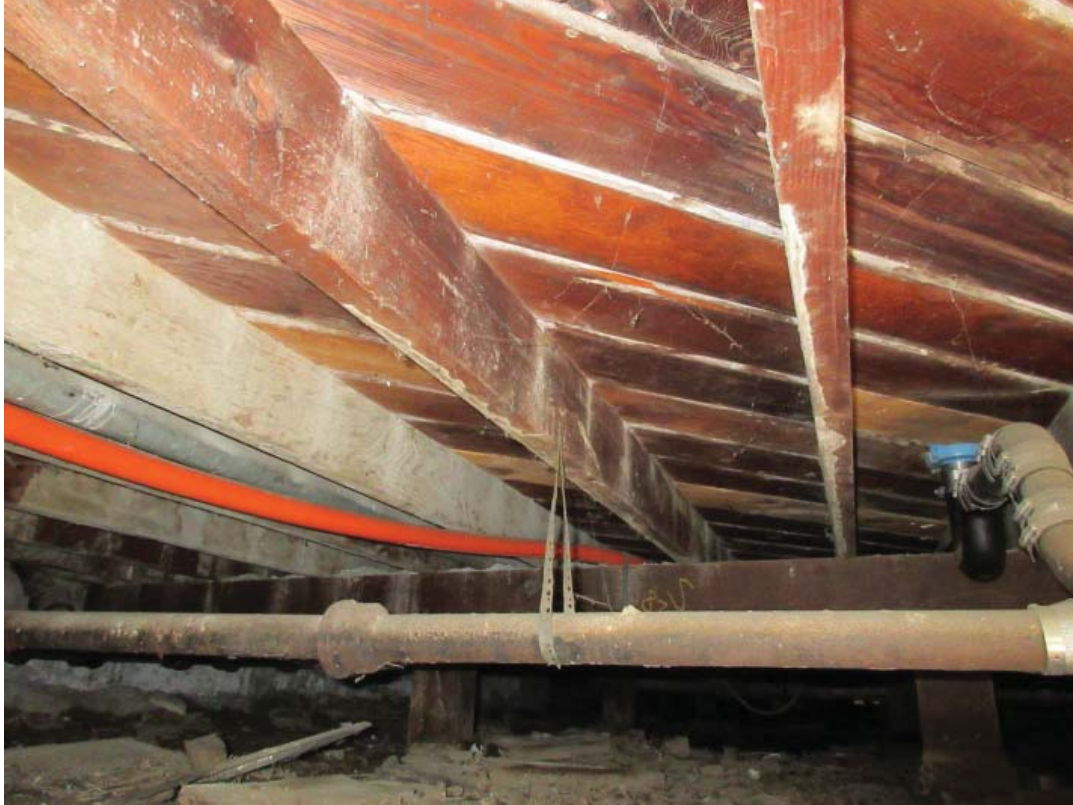
Photo 21 – Framing at south side crawl space below restroom.

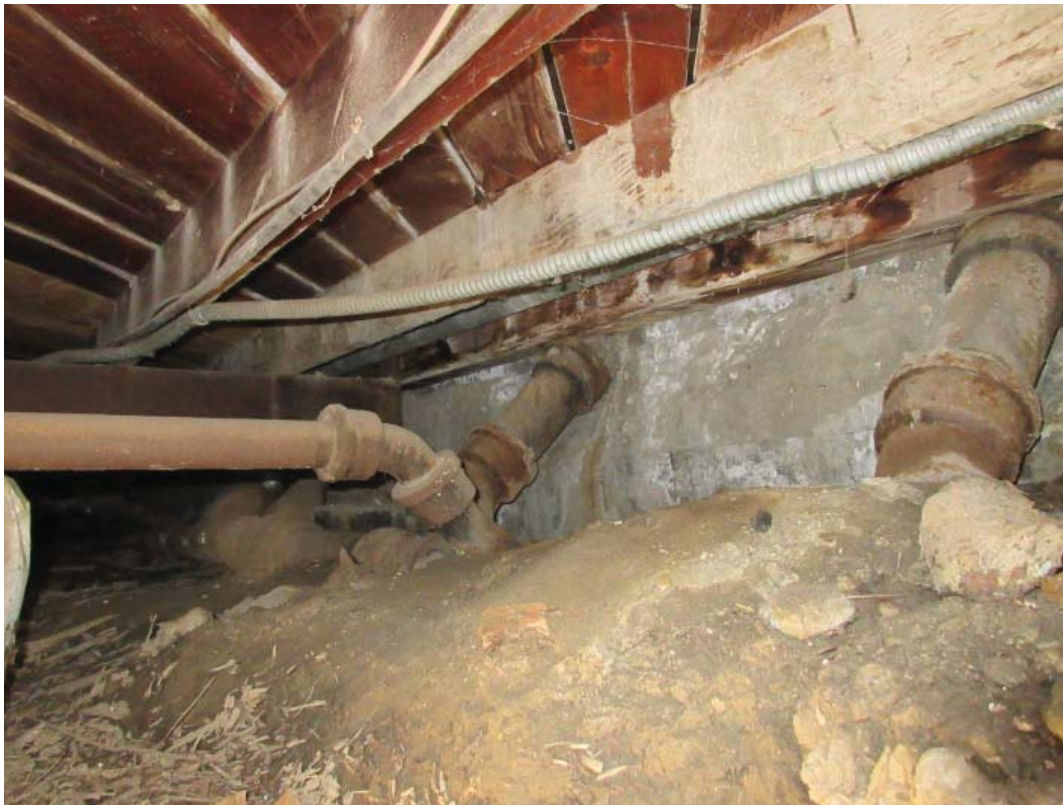
Photo 22 – Framing at south side crawl space below restrooms.

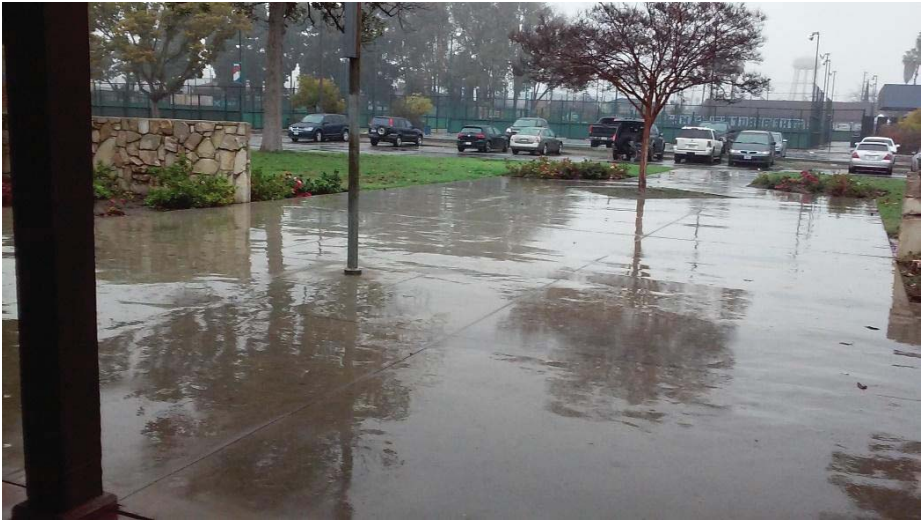
- Along the east side of the GCH, which is the main entrance and areas further to the east is a parking area, see figure 3. Accordingly, based on field inspection during the rainfall event. It is observed that puddles of stormwater run-off are visible along the main entrance walkway path of travel and people have to walk around to avoid shoes getting soaked in these puddles, see figure 3. For plan reference to all figures in this section, refer to figure 2.

Figure 3: Front concrete walkway where there is no existing storm water drainage system

- Along the east side of the GCH, this area should be regraded to slope to areas that will prevent the storm water from puddling throughout the hardscape. For visual, please refer to figure 3.
- Northside of GCH building - since this walkway is in bad condition it should be regraded and repaved to slope towards the landscape area at a 2% maximum slope. This regrading will help prevent any future issues similar to the same issue as in figure 4 and 5.
- Southside of GCH building- similar to the north side the south side should be regraded so that the concrete will slope away from the building to prevent any more damage to the structural integrity of the structure. Such as the issues currently faced in figure 6.

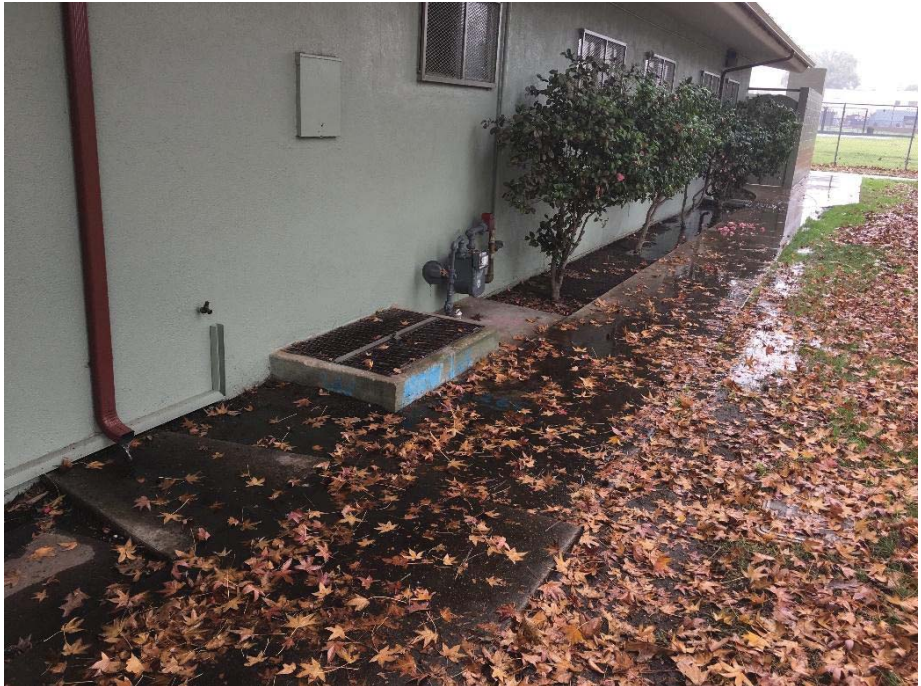
- Northside of GCH building – It appears that some of the stormwater run-off water ponds along the existing walkway during a rain event. This indicates that the walkway is lower than the adjacent area and run-off water has difficulty to sheet flow further to the north landscape areas, see figure 4 and 5. It was observed that part of the area is partially sloping towards the building. Positive drainage may be needed and diversion of water run-off towards the lower level must be done not only on this side but also on all sides around the building.

Figure 4: On the north of the Girls Club House storm water ponds on the walkway

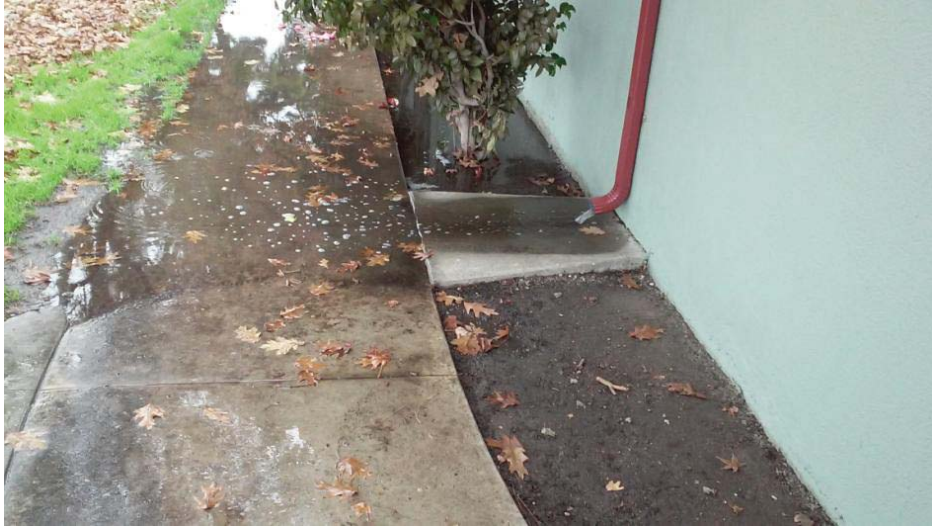
Figure 5: On the north side of the building water ponds on the walkway and partially flows back towards the building affecting the structural integrity of the building.

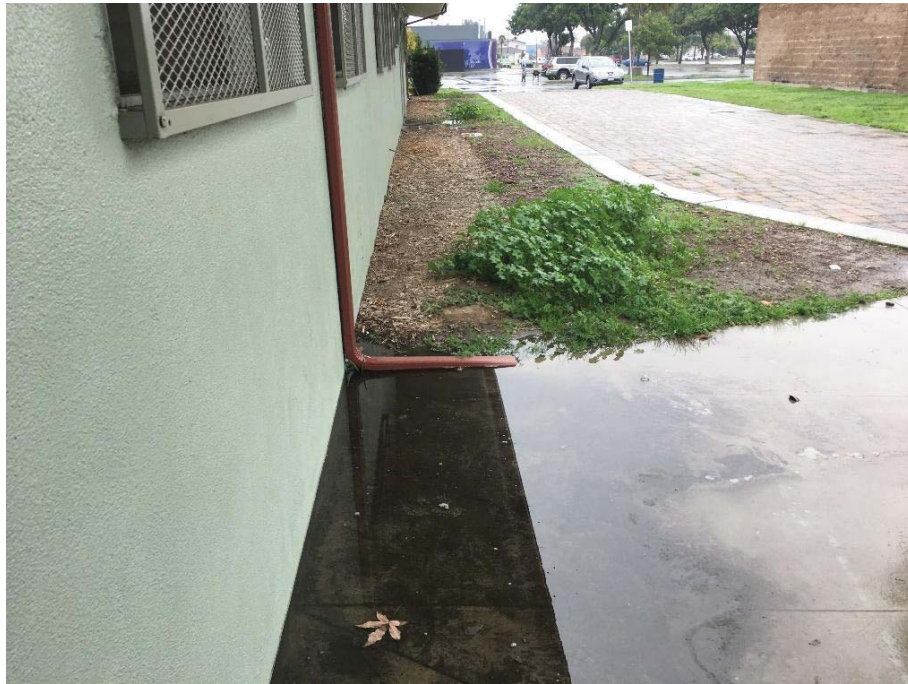
- Southside of GCH building - In figure 6, run-off water coming from the downspout has observed to be ponding along the concrete surface area next to the wall and downspout.

Figure 6: On the south side of the building water ponds on the concrete area from the buildings storm water

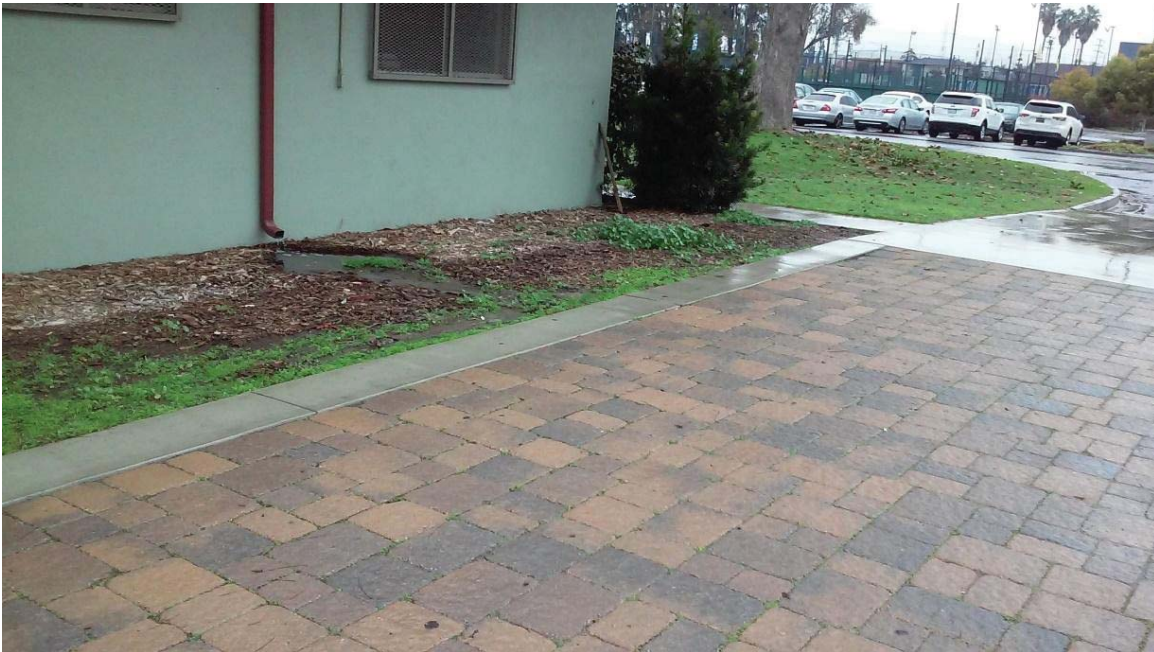
Figure 7 shows that water is ponding in the landscape area by the building. It appears that this run-off water and ponding from the roof downspout will consequently affect the building wall. Proper positive drainage should be done and protection of the wall may be needed.

Figure 7: On the south side of the building water ponds on the Landscape area from the buildings storm water downspouts

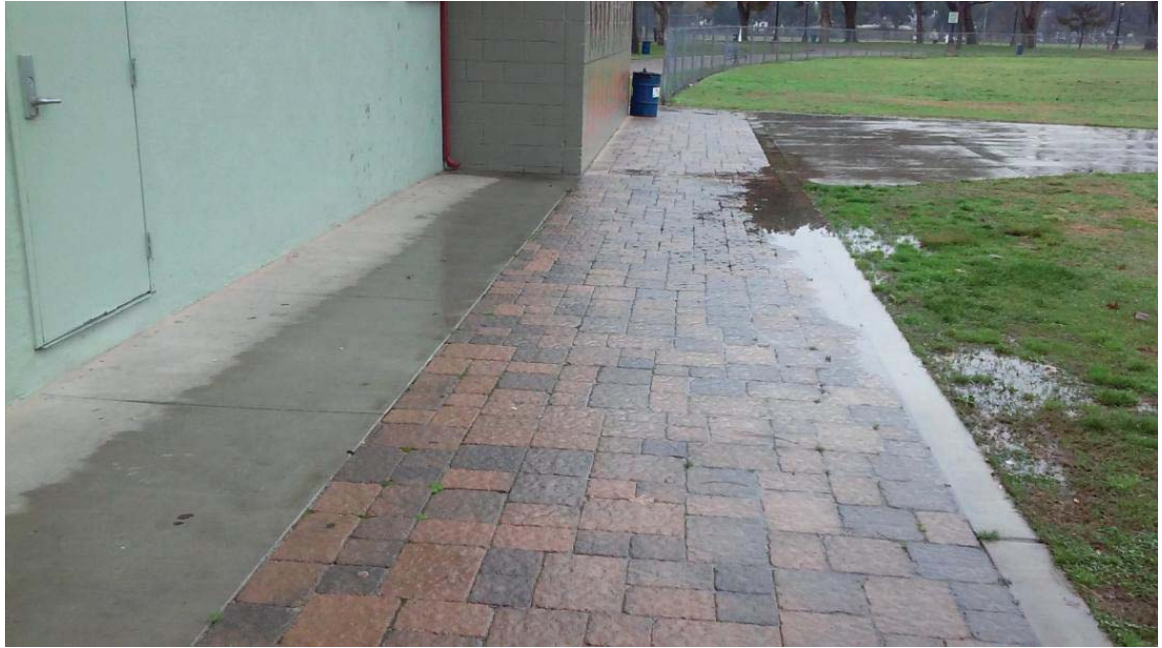
- Westside of the GCH building – Two downspouts see figure 8 and 9, along this side are discharging directly to the surface of the walkway and flows towards the landscape area. The landscape adjacent to the walkway appears to be lower than the walkway that allows the run-off water from downspout to sheet flow towards the landscape. However, some portion of the landscape areas are higher than the walkway. Run-off water tends to pond in the south part because the walkway and landscape area is lower, as shown in figure 10.

Figure 9: Water from downspouts flow into existing walkway in the back of the building

Overall, since there is no existing stormwater drainage system on-site then it is highly recommended that the stormwater be redirected towards the curb and gutter located along the parking lot as shown on figure 11, 12, and re 13. The stormwater from the downspouts and hardscape will curb drain to the existing curb and gutter flowing the water off site and into the cities storm drainage system. Regrading in the landscape area might be required in order to create stormwater flow to end up in the curb and gutter towards the east.

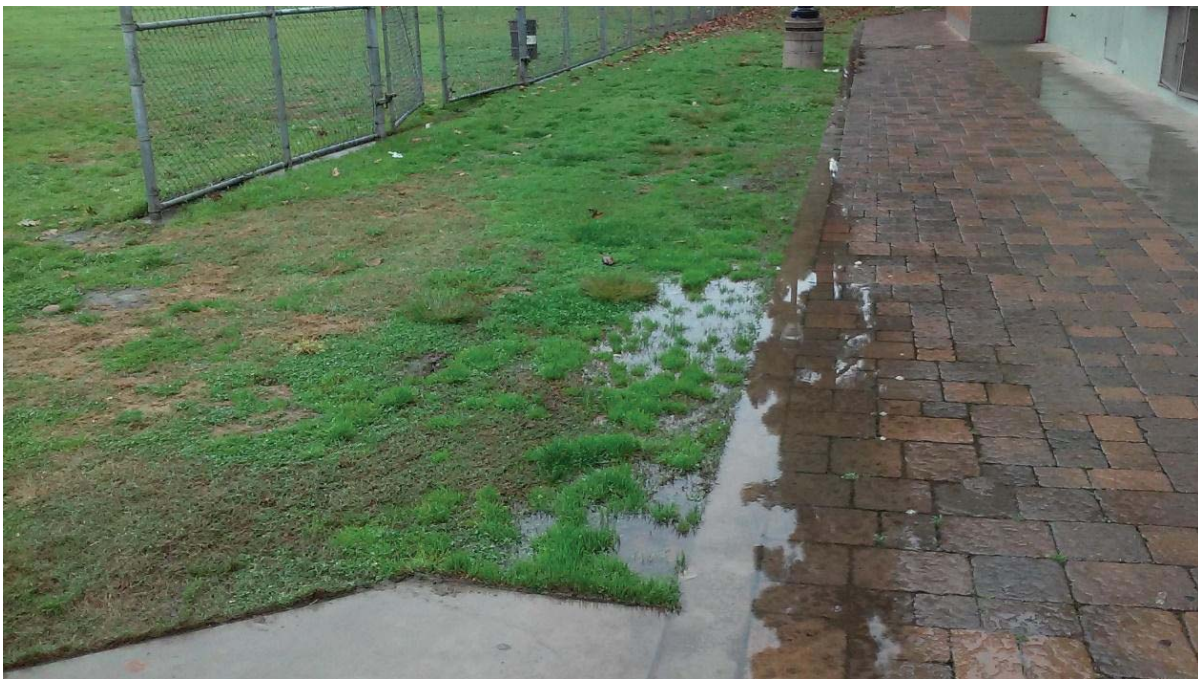
Figure 10: Ponding area in the back of the building where the walkway and landscape meet

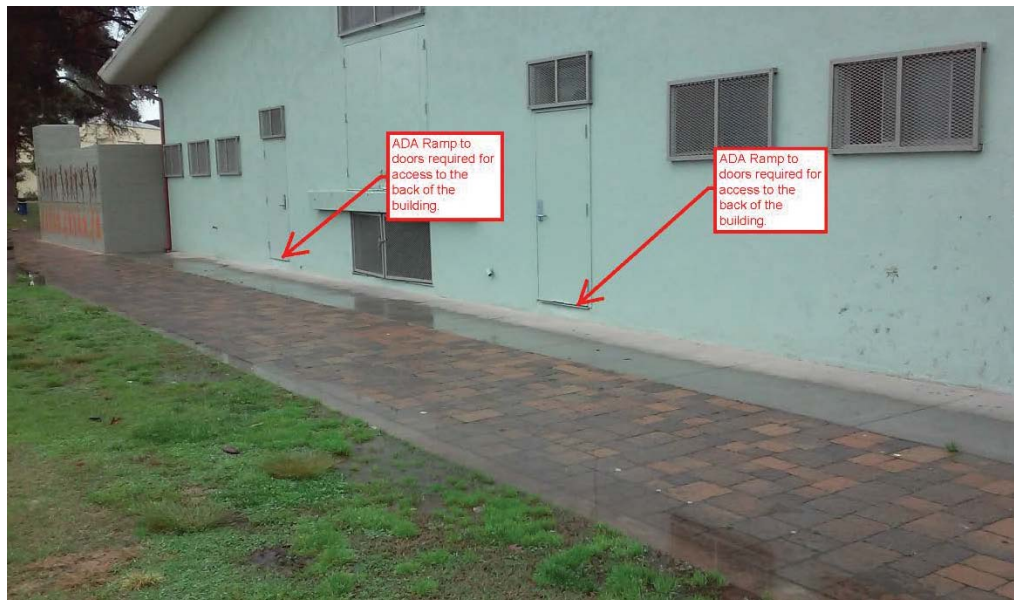
Figure 16 and 17 below show the current existing ADA path of travel to the Girls Club House. There currently are 3 existing ADA parking stalls next to an accessible path which leads to the main entrance of the existing building. An issue we currently found on-site is that the 2 access doors in the back of the building will are not ADA compliant as shown on figure 18. The access to these doors will need to be ADA compliant by adding a ramp. Per the County of LA ADA requirements, if any ADA access is between a 2-5% slope then it is considered a ramp and if the slope is between 5-8.33% then the ramp will require handrails. No ADA ramp may exceed a slope of 8.33%.

Figure 18: Non-compliant ADA accessibility in the back of existing building
