SOUTH GATE GIRLS CLUB HOUSE

FEASIBILITY STUDY DRAFT REPORT

LEHRER ARCHITECTS LA FEBRUARY 22, 2017

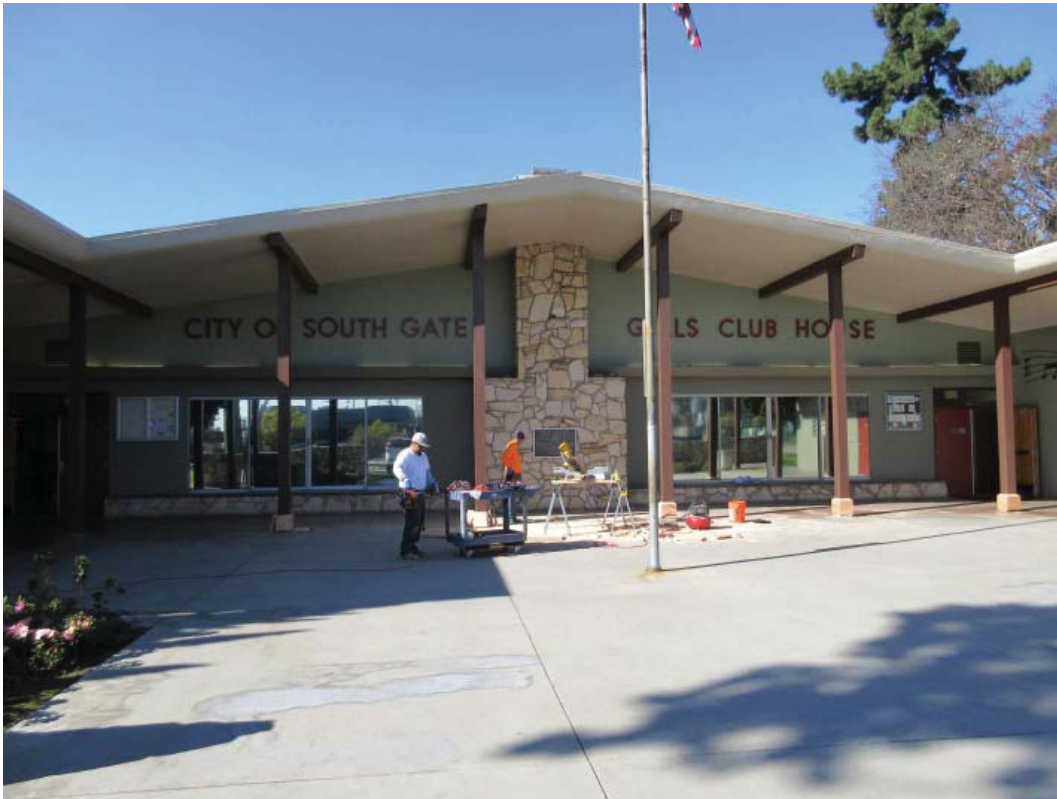
Photo 1 – Front entrance east elevation.
